Roofing

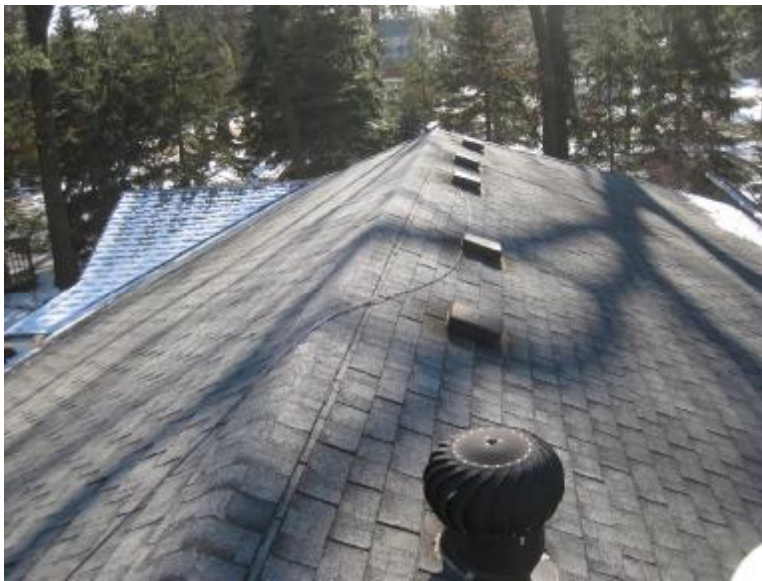
1. The shingles are older, but appear to be in serviceable condition. Recent repairs were observed at the skylights, valleys and chimneys. Regular inspections by a qualified roofer are recommended. If local repairs are performed as required, the shingles could provide up to 5 years of service before complete replacement is required.

Overview of roof.

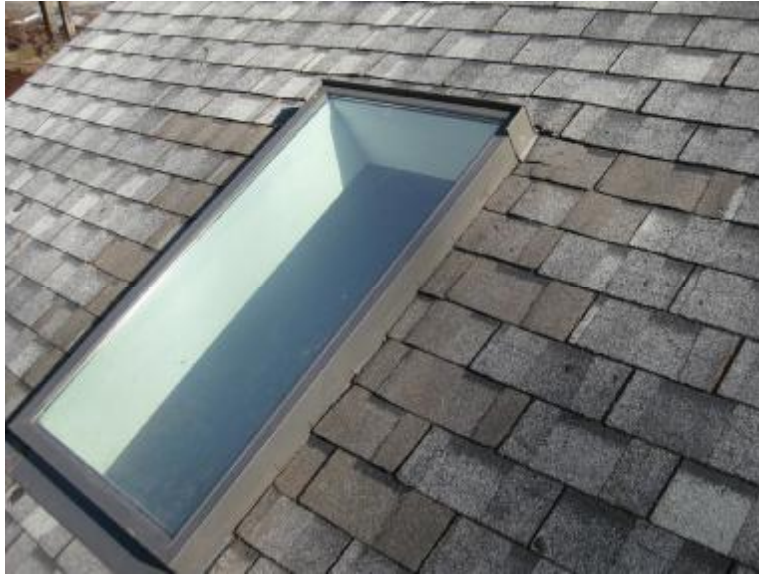
Recent repairs at skylight.

Attention should be paid to the valleys and skylights. Skylights are prone to water leakage. Repairs were noted at two of the skylights. There was no evidence of current water leakage problems at the skylights.

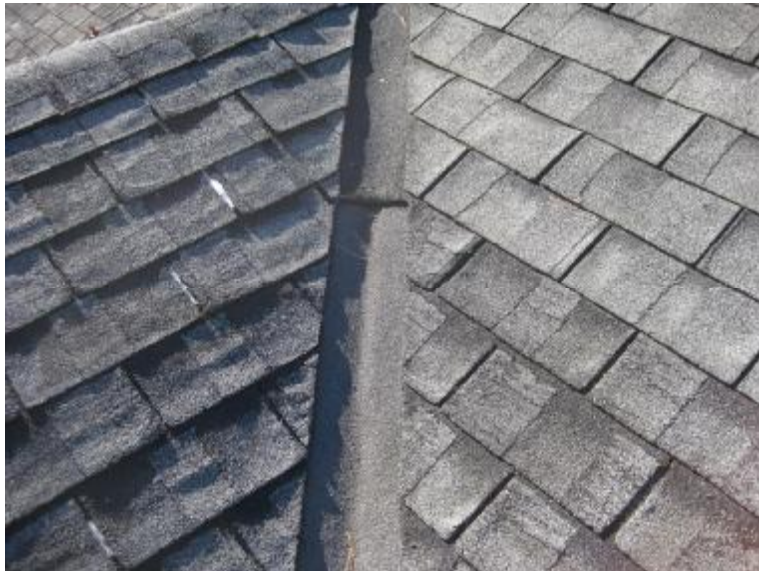
Shingles are cracked and curled; indicating they are older. Recent repairs to the valley are evident.

Valleys are subject to higher wear than the field of the roof. Recent repairs were noted at the valleys. When the shingles are replaced, installation of pre-painted metal valleys is recommended.

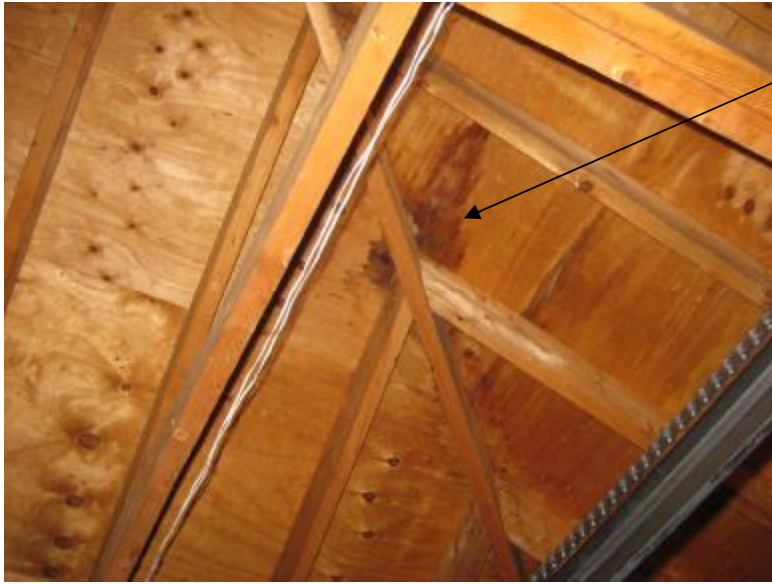
2. A stain was observed on the underside of the roof sheathing in the garage. This appears to be a result of a previous leak. No problems were apparent with the shingles in this area.

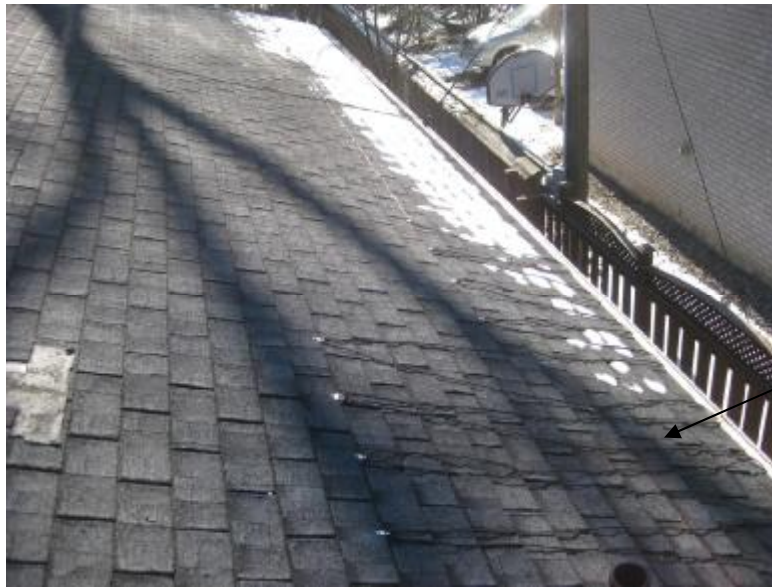
3. Heating cables have been installed at the north side of the roof. This was likely done in response to an ice damming problem. See Insulation section for a discussion of ice damming.

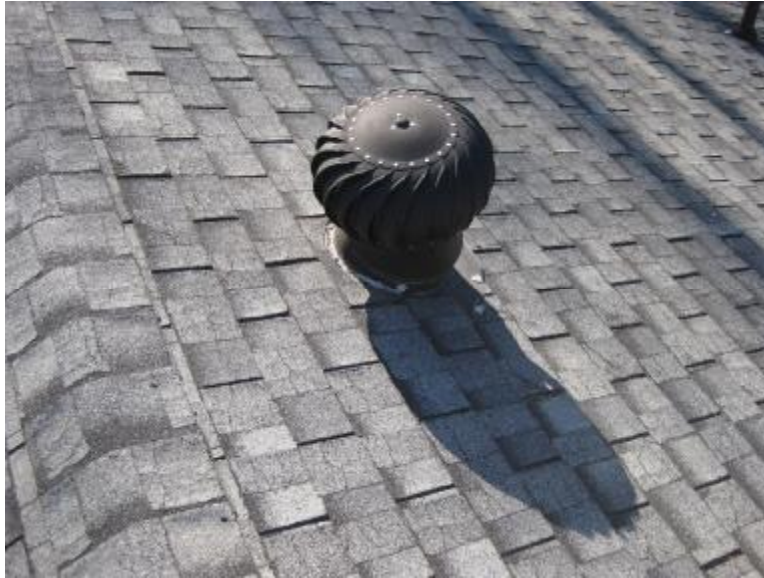
4. A turbine vent has been installed on the roof. Turbine vents are not recommended. They only contribute to venting during windy conditions, when passive roof vents are effective by themselves. They can cause excessive de-pressurization in the attic and are prone to become noisy as they age.

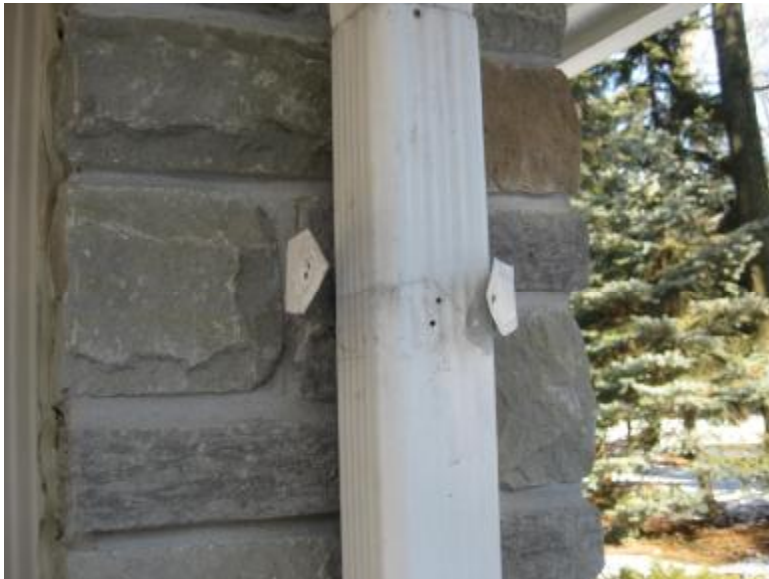
5. A downspout at the left front corner of the house is loose. It should be repaired.

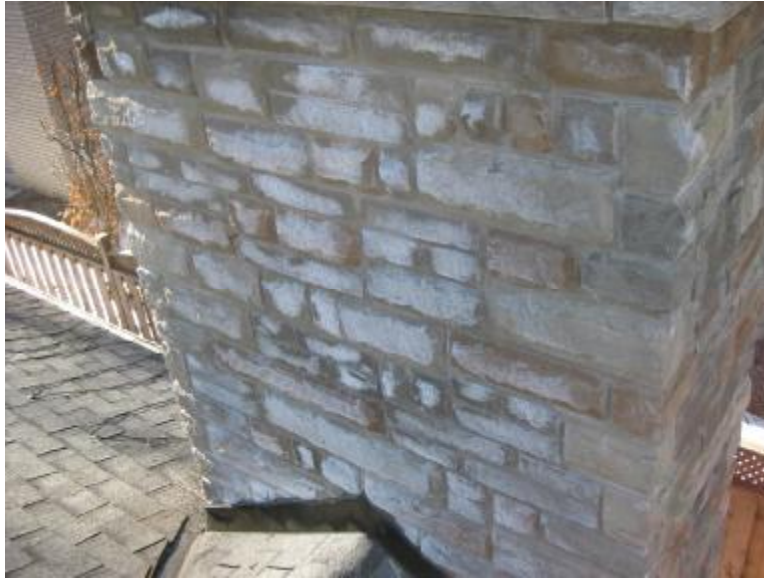
6. Efflorescence was observed on the masonry chimney at the right rear. It appears to have been caused by wetting from rain or melting snow and if this is the case, it is not a serious concern. The chimney should be monitored and if excessive deterioration of the masonry is noticed, corrective action should be taken.
